Optima / Sorento / Sportage Sunroof Glass Status

Kia Motors America 05/31/2013

Panorama Sunroof Glass Summary

XM Panorama Glass Investigation

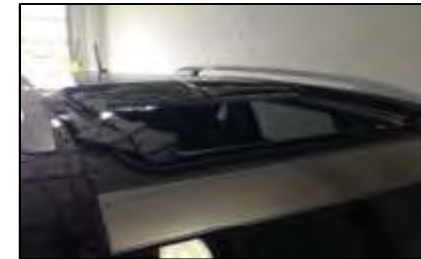
- During investigation there were some witness marks noticed on the roof near the antenna that may indicate that the customer potentially mounted something to the roof which could have potentially damaged the glass. However no roof rails were present.

- After initial analysis of glass fragments, tempering of glass appears to be within specification.
- After initial analysis of all brackets, there is no evidence of e-coat failure between glass and brackets.

- **After glass analysis by Guardian, damage to glass appears to have started on right side of the glass. No other areas on the glass present showed a web-like break pattern as found on the right side. The web-like break pattern indicates where the crack began due to some sort of external impact to the glass.**

- Review process at Glovis and KMMG to verify proper handling of glass and ensure glass is not damaged prior to install.
- Webasto obtained all brackets from unit for further testing. Supplier will also check pano build history using barcode present on bracket to verify this pano roof had no prior repair concerns. All information will be included in their report.
- Guardian (Glass Supplier) obtained several fragments of glass from unit to verify tempering. Also requested additional inspection of glass before shipping. Supplier will also compile a report of results of additional testing.
- Recommend R&D evaluate and move to design similar to that of the Kia Optima.

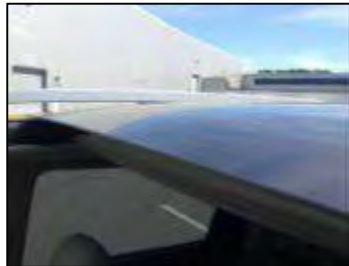
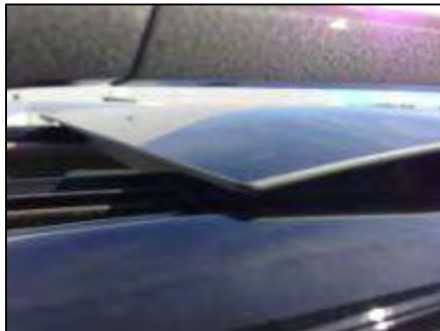
Panorama Roof Comparison				
Kia Sorento		<div>Front</div>

<p>Glass has no protection around the edge similar to Hyundai Veloster.</p>	<div>Side</div>

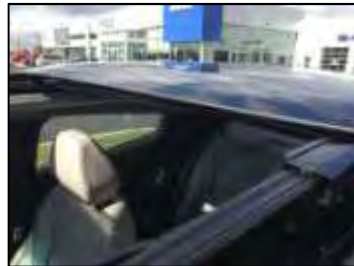
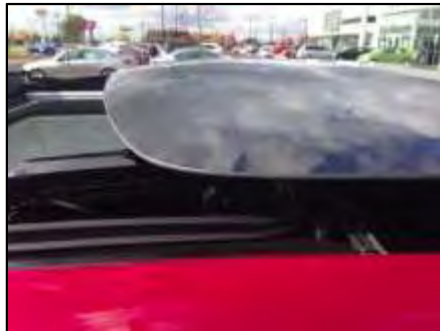
Hyundai Veloster		<div>Front</div>

<p>Glass has no protection around the edge similar to XM.</p>	<div>Side</div>

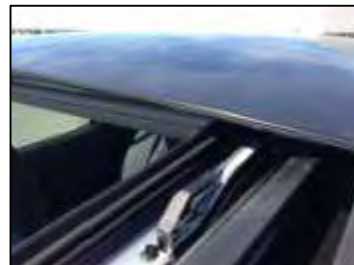
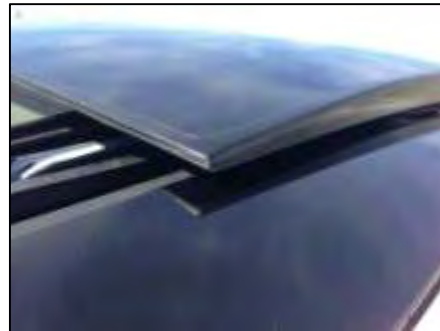
Kia Optima		<div>Front</div>

<p>Glass edge is protected to prevent damage from impact unlike Veloster and Sorento.</p>	<div>Side</div>

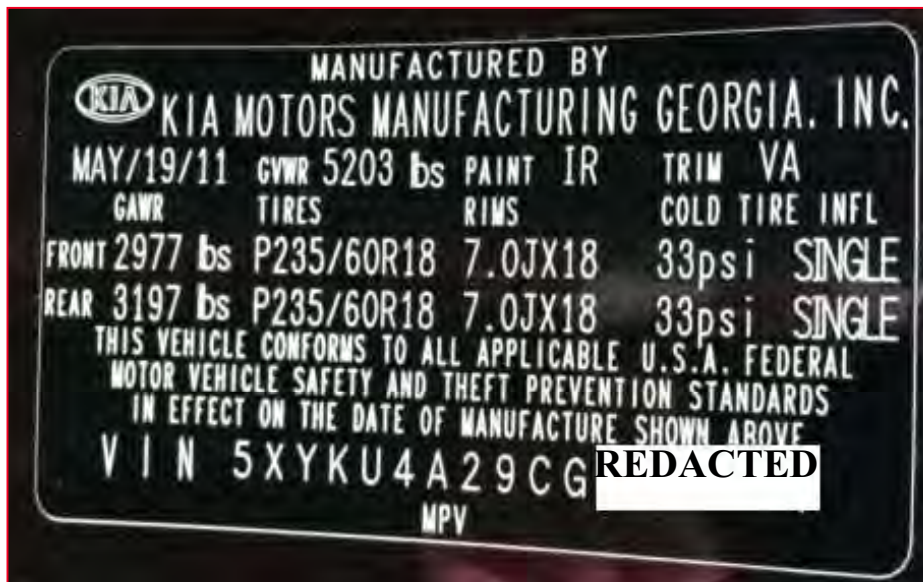
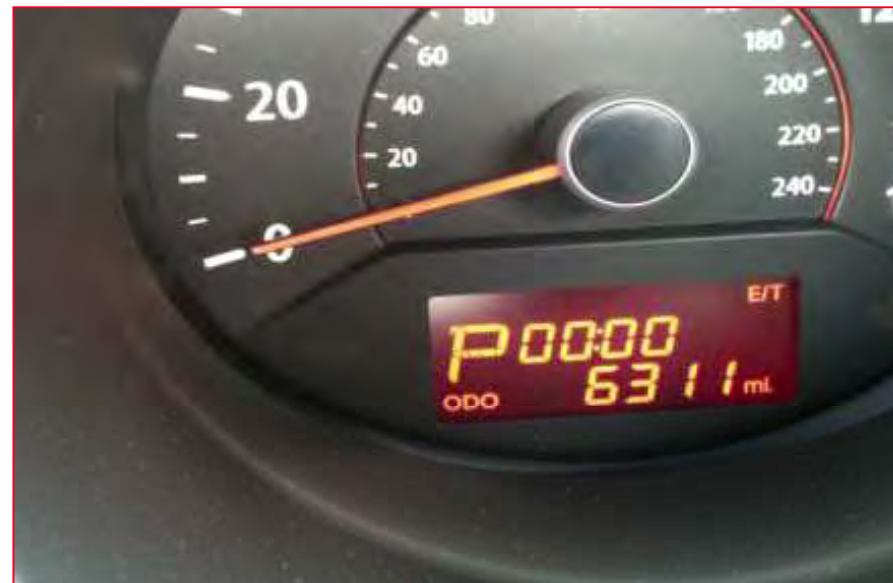
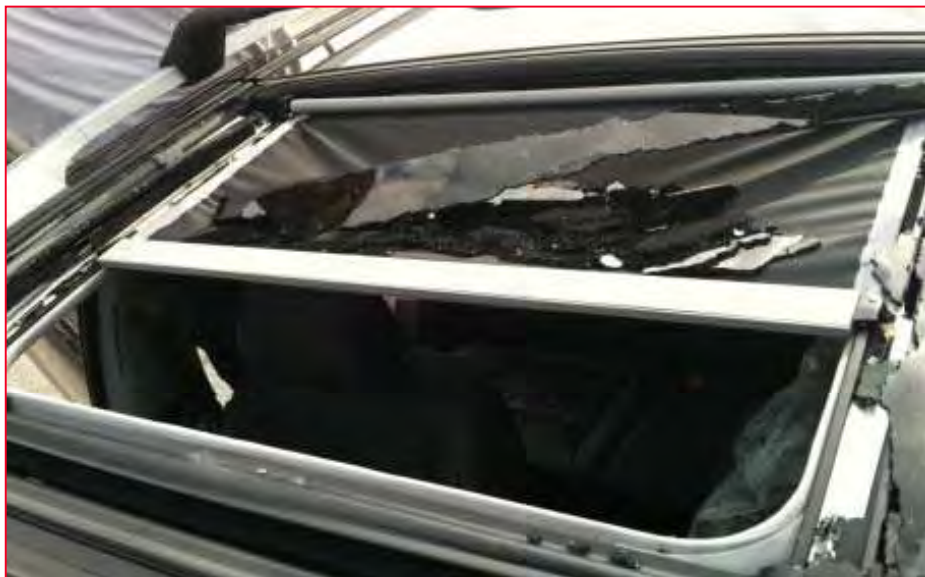
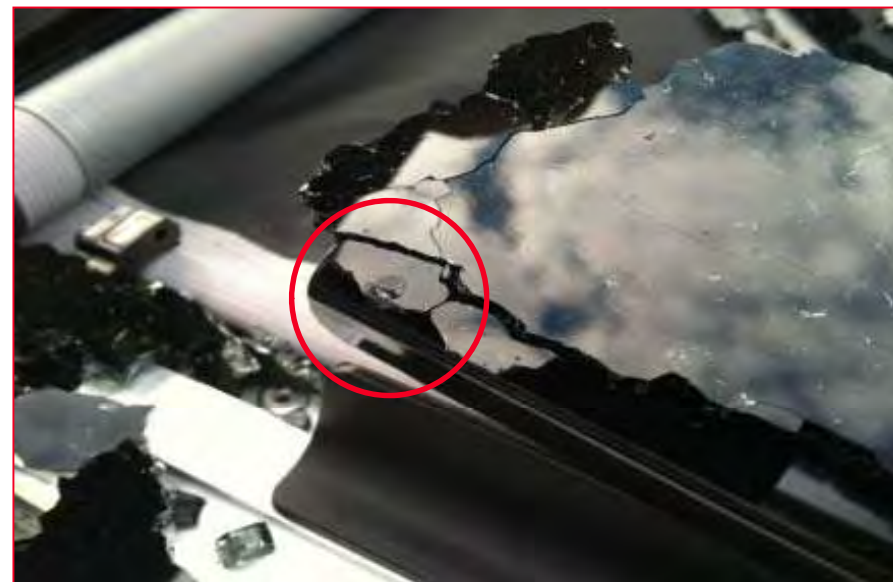
Concern

Panorama Glass Fragmented

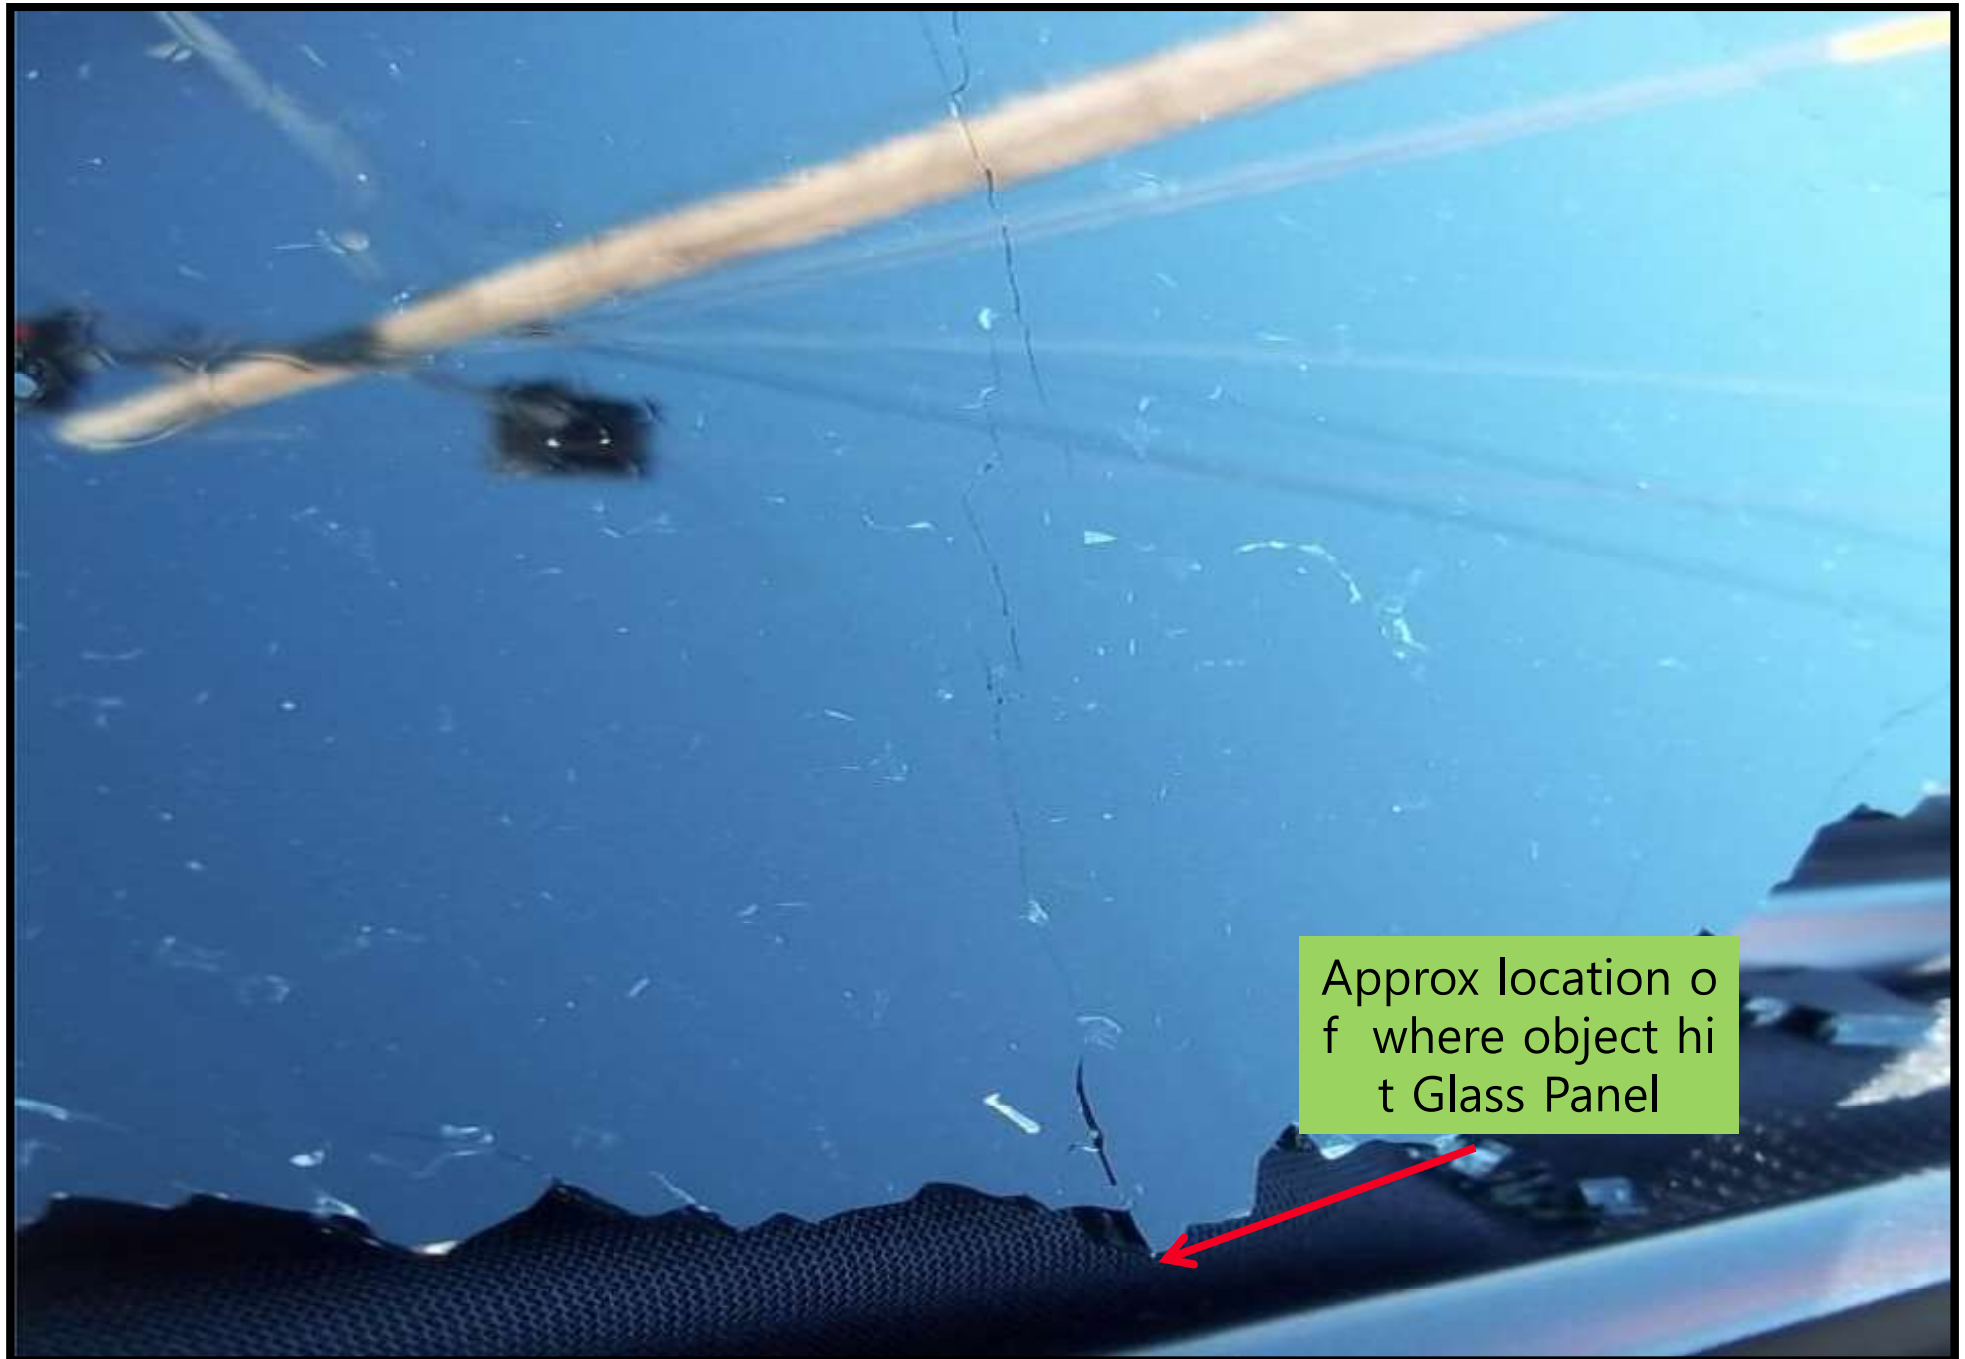
Approx location o
f where object hi
t Glass Panel

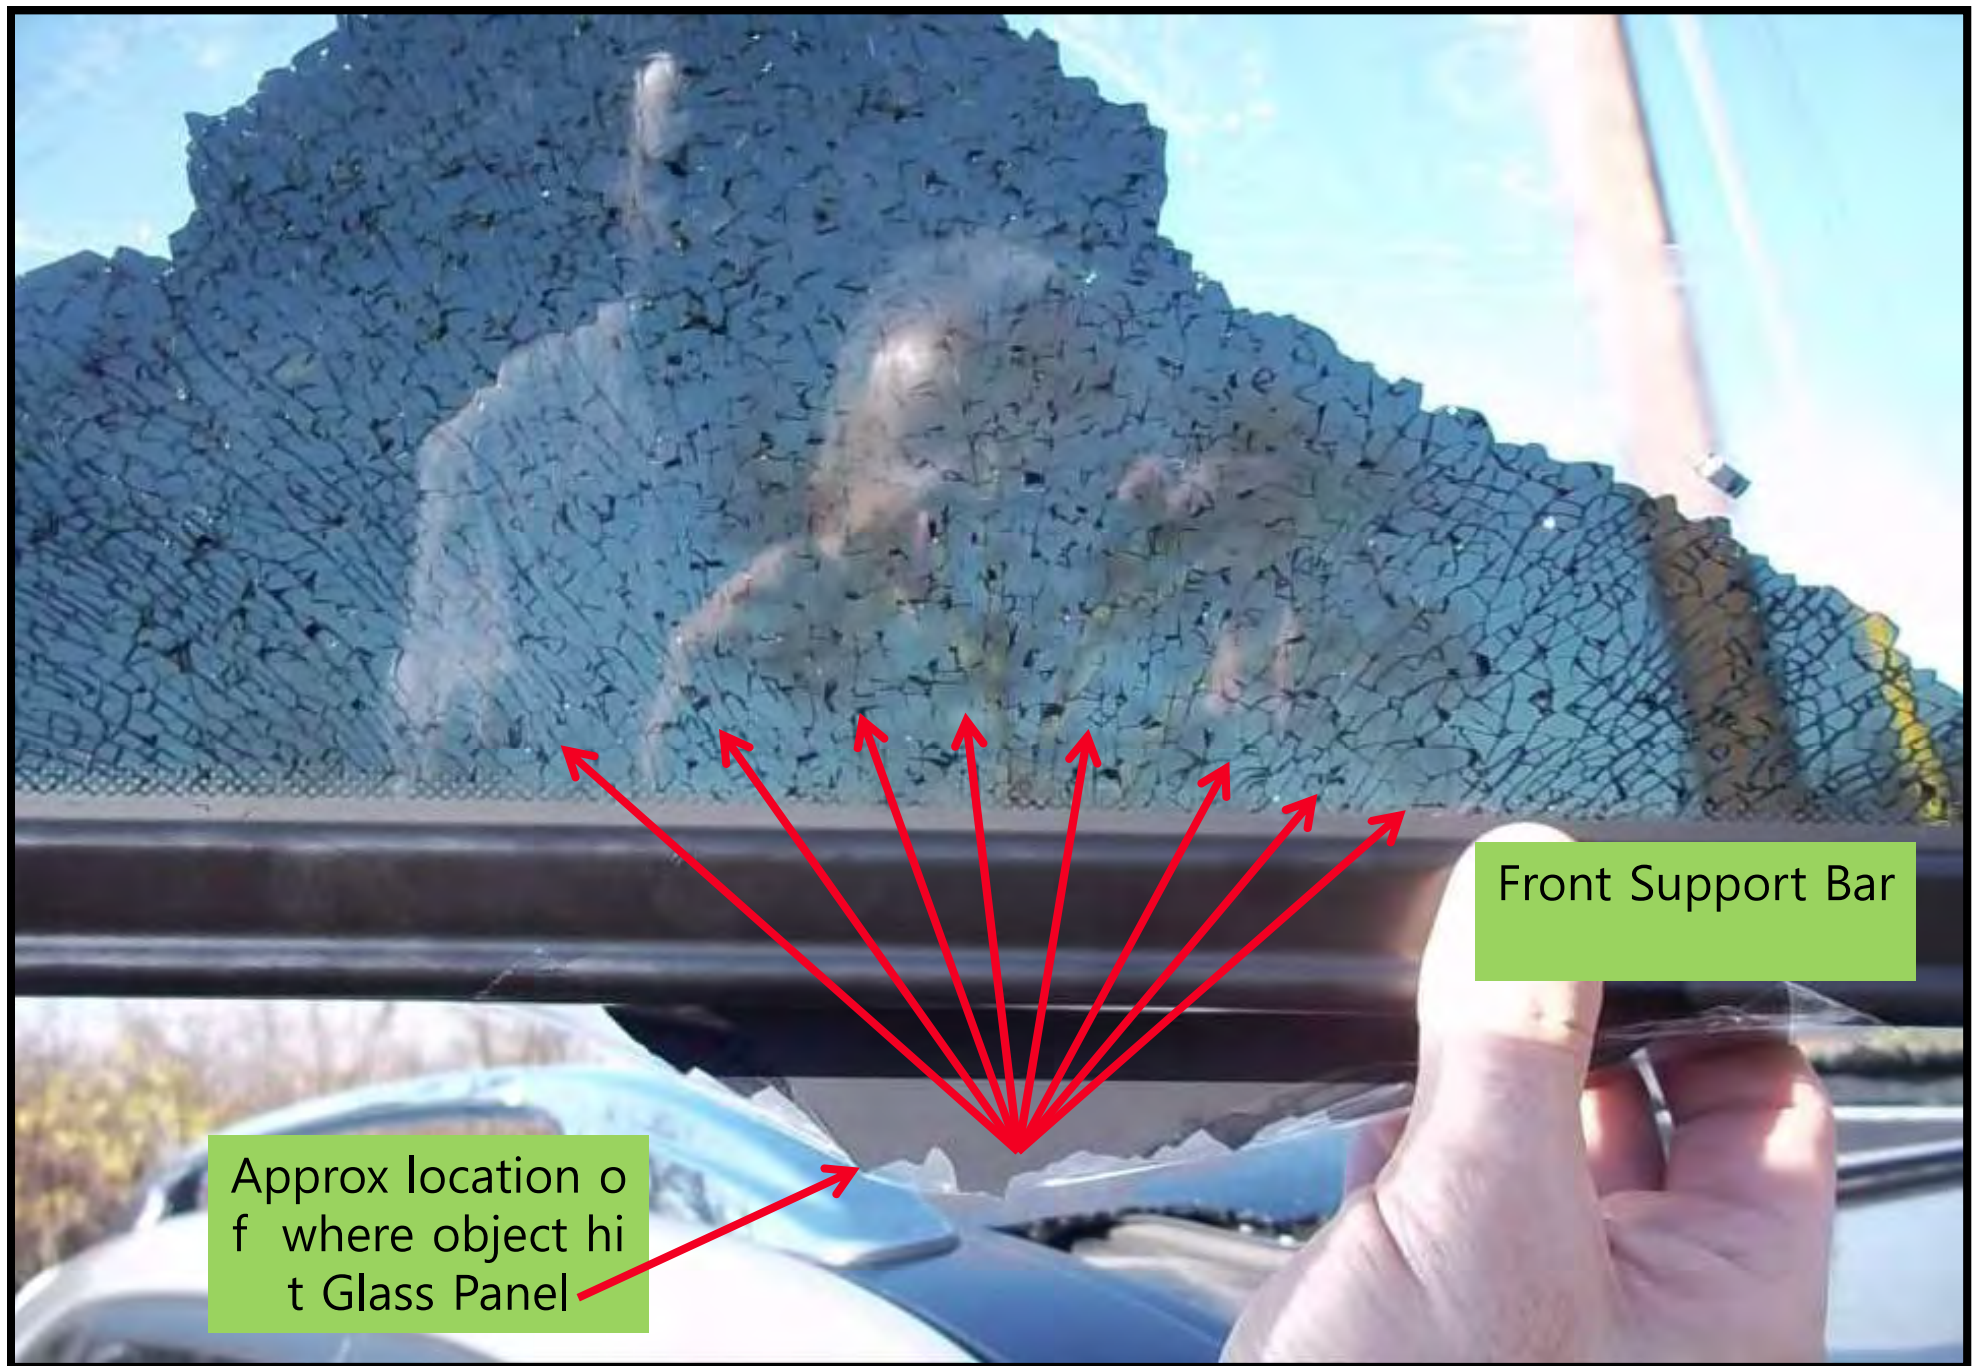
Approx location of where object hit Glass Panel

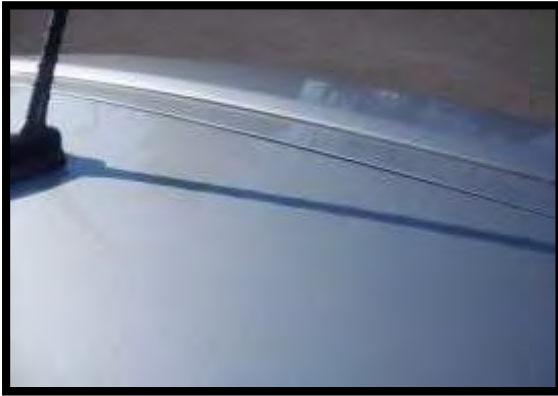
Paint chips on rear of roof from Glass shatter and spraying back while driving

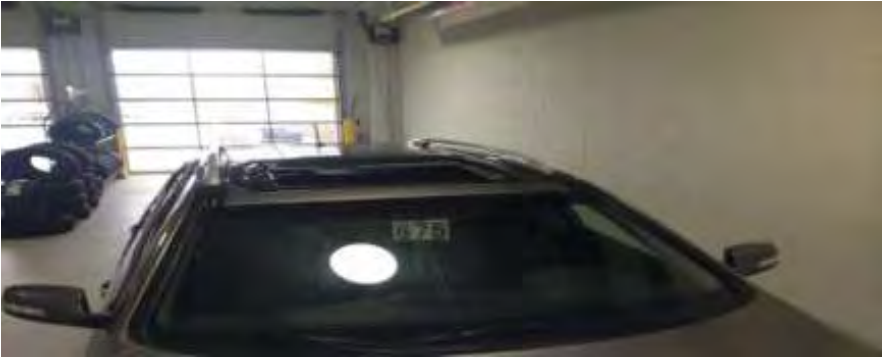
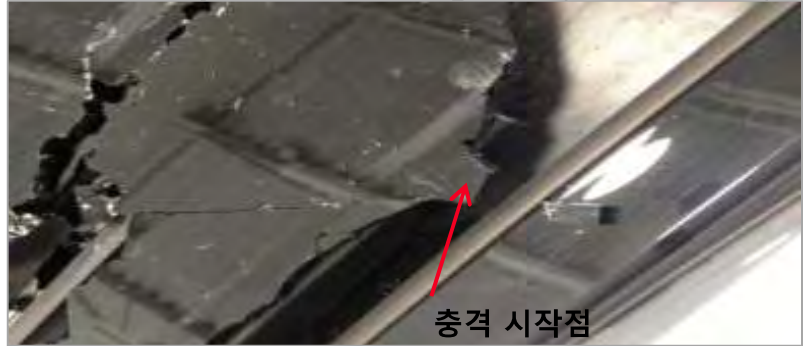
<p>▶ Cause: External Impact is suspected</p> <p>▶ 불량율 : 0.02% (12건/75,364대)</p> <p>※ 대상 차량 - 75,364대 (09.11/15 ~ 현재) - 파노라마루프 옵션Only</p>	※ 차량 정보 #	T2373852	VIN	5XYKUDA24DG <small>REDACTED</small>	주행거리	3,339 mile	판매딜러	Fox Kia	발생지역	Grand Rapid, MI	<p>[Problem Vehicle Results]</p> <p>※ Joint Investigation (12.10/17)</p> <ol style="list-style-type: none"> 1) Affiliates: KMMG,KMA,베바스토 2) Evaluation <ul style="list-style-type: none"> - Impact glass on the end of glass breakage investigation trail area 3) Analysis <ul style="list-style-type: none"> - External Impact was identified as "Root Cause" - Without glass edge protection, rock impact can be attributed to condition and maybe a disadvantage compared to competitors

<p>[Field Fix]</p> <ul style="list-style-type: none"> - Replace fragmented glass with new glass <p>FPQR</p> <p style="text-align: right;">업체 : 베바스토</p>
※ 차량 정보 #	T2373852										
VIN	5XYKUDA24DG <small>REDACTED</small>										
주행거리	3,339 mile										
판매딜러	Fox Kia										
발생지역	Grand Rapid, MI

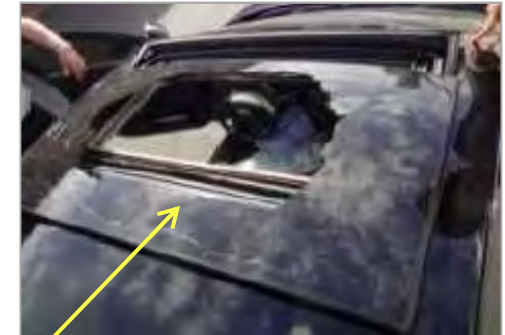
❖ During the inspection, TFT observed fragmentation had occurred in the center of glass. Fragmentation occurred from the center of the glass and as a result, consequential damage occurred to the paint.

❖ The Investigation results are **Inconclusive** as to the "Root Cause" of this condition. Panorama sunroof front glass was recovered for further analysis.

Fragmented in Center of Glass

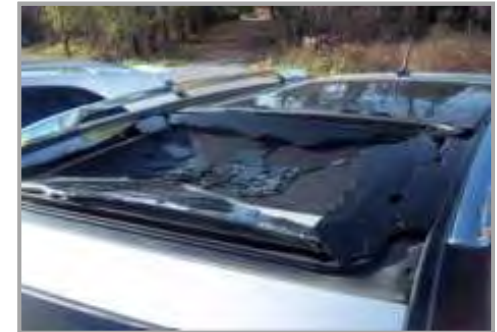
❖ Initial investigation confirmed the sunroof glass had fragmented and fell onto the sunshade. Further inspection reveals impact witness mark on the hood and on the surface of the glass. The witness mark on the hood was tracked to the impact mark (initial fracture) on the leading edge of the glass. The cracks propagated to the center causing the glass to collapse onto the sunshade. Consequential damage occurred to the paint from broken glass contact at highway speeds.

❖ The Investigation results are **conclusive** as to the "**Root Cause**" of this concern. The glass was cracked by a foreign object. Panorama sunroof front glass was recovered for further analysis.

Fragmented in Center of Glass

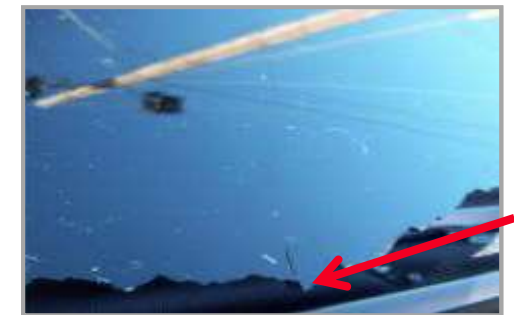
Location of Initial Impact

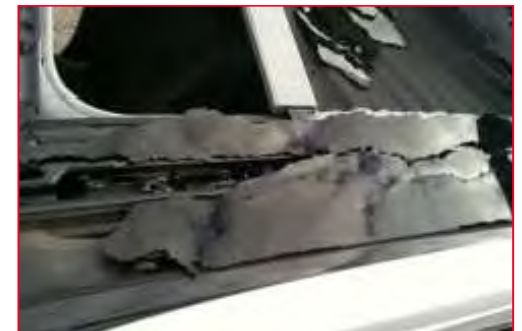
Glass attachment to frame was good

- ❖ Remaining glass pieces and supporting frame were taped up to prevent further damage during shipping
- ❖ The glass and all four reinforcement bars were sent to Rochester, MI for further analysis in the lab
- ❖ The glass temper and cracking angles will be investigated and reporting will be sent to KMMG
- ❖ FPQR

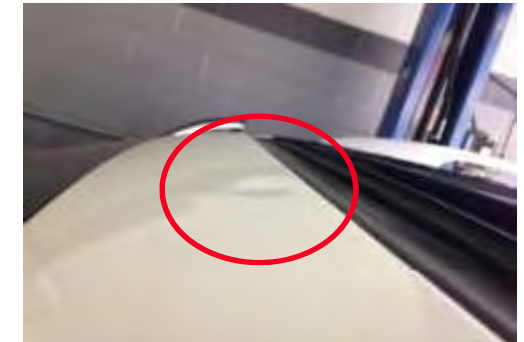
- ❖ Large dent which should have required some force found on left side of roof very close to leading edge of glass was most likely the impact which caused glass to shatter

Large Dent Near on Roof Near Glass

2. Large dent at left side of roof panel. This dent is in right at the leading edge of the glass and an object which impacted with the force necessary to cause such a dent this close to the glass would also shatter the panoramic roof glass. We can demonstrate this on video showing a measured weight coming down at known velocity to exhibit similar dent and shatter the glass should this evidence be necessary for trial

- ❖ Vehicle currently part of a CA case and Pano Roof assy is not be removed but preserved in place for evidence
- ❖ Pano Roof glass fragmentation does not appear to be due to any material defect but rather it was due to impact with road debris and thus it is not going to be valuable for further investigation by the supplier or KMMG

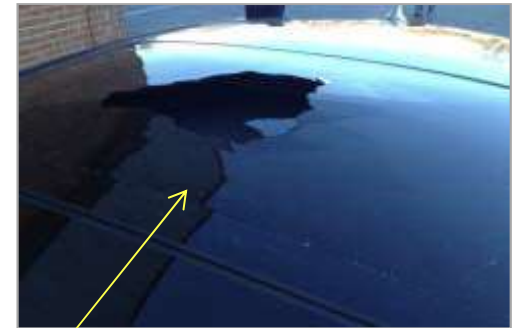
❖ During the inspection at MD042 on 12/17/2012, FTR observed a fragmentation had occurred in the center of glass.

Photo Above Before Inspection

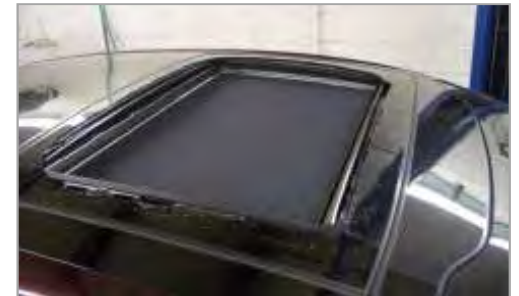
❖ The Investigation results are **Inconclusive** as to the "Root Cause" of this condition.

Evaluation Inconclusive

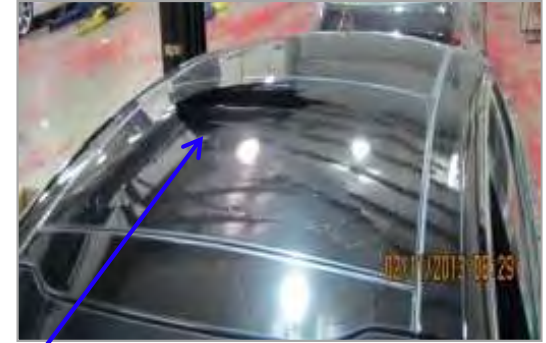
- ❖ VIN = KNAGM4AD3C5^{REDACTED} / MILES = 420
- ❖ 12MY TF Hybrid
- ❖ The vehicle was traveling down the highway 281 at approx 60MPH around 4:00pm between the city of San Antonio and Austin, TX.
- ❖ The customer heard a loud noise followed by glass the sound of fragmented glass contacting the vehicle.
- ❖ The sunshade was closed, the windows were up and the A/C was on and in recirculation mode during the incident.
- ❖ The ambient temperature was ~85 degrees Fahrenheit with light winds present – this was a record setting temperature for the area.
- ❖ No other vehicles driving by. The vehicle was not traveling in a tunnel or under an overpass.
- ❖ A large amount of residual glass was not found on the sunshade.
- ❖ No obvious point of impact was found.

Fragmentation of Sliding Glass

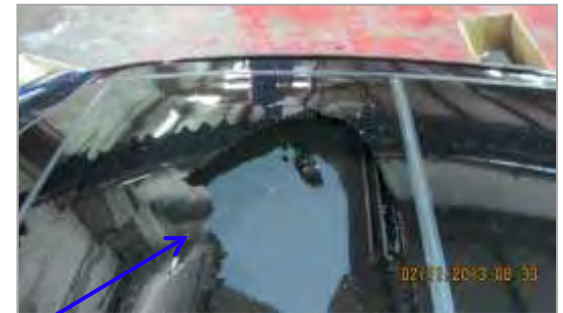
Fragmentation occurred while driving

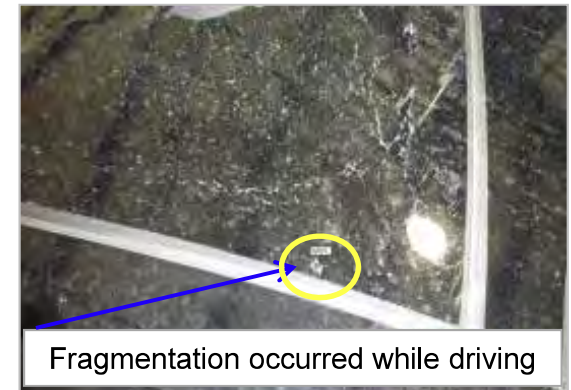
- ❖ Found that the glass had fragmented, and there was a chip, in the glass near the edge at the RF of the sunroof

Impact Mark Identified

Fragmentation occurred while driving

- ❖ **Corrective action** – Replace sunroof glass assembly, clean area of glass.

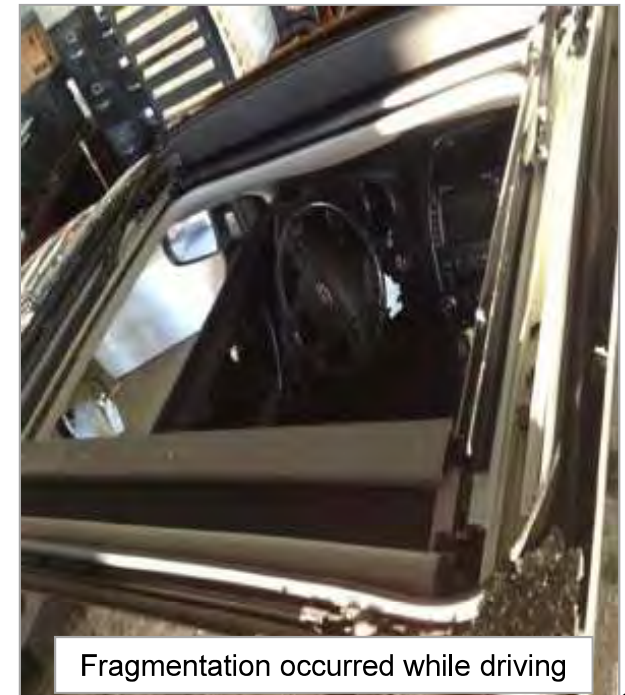
- ❖ Sunroof glass was completely fragmented (broken)

- ❖ Found no external damage to vehicle caused by debris.

- ❖ **Corrective action** – Replace sunroof glass assembly, clean area of glass.

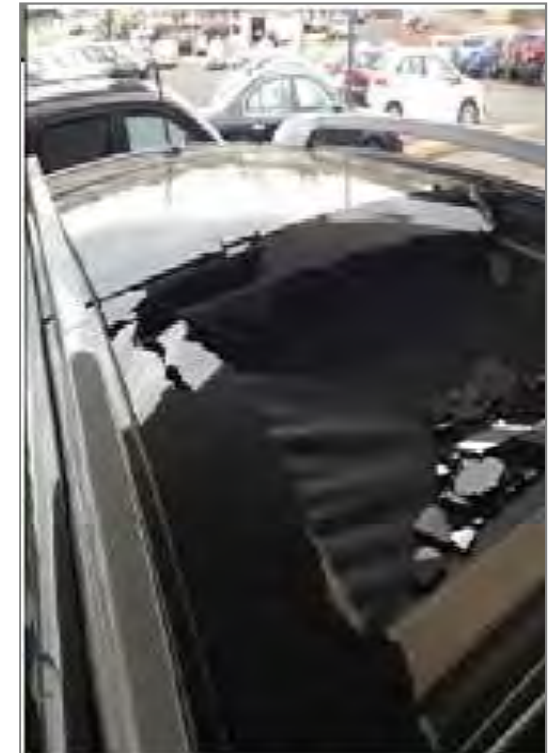
❖ Sunroof glass was broken upon inspection

❖ FTR investigated the customer vehicle. When inspected - the sunshade was fully closed - I was informed that the customer closed to shade after the glass shattered to catch any remaining glass that may fall in the vehicle. There was some glass accumulated in the top of the sunshade, but the majority of the glass was inside the vehicle. The vehicle exterior was inspected and two (2) rock chips were found on the front windshield. There were no rock chips found on the front of the vehicle or the hood area. There was excessive paint chips to the rear of the roof, antenna assembly, and one large chip in the rear stationary glass assembly. Due to the extent of the glass breakage it could not be determined where the point of impact was on the sunroof glass.

❖ Cause - Unknown

❖ Corrective action – Clean vehicle and replaced movable sunroof glass assembly.

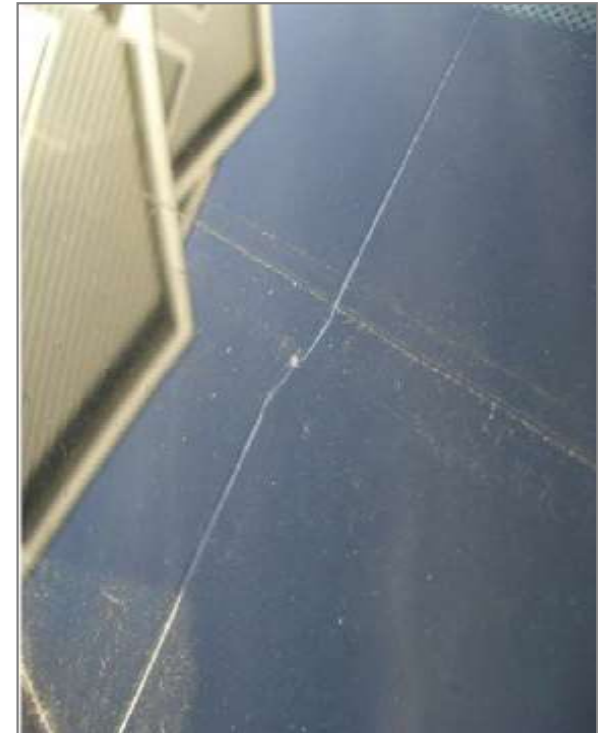
❖ FTR inspected the subject vehicle for concern of sunroof shatter. During my inspection I found the sunroof was totally shattered. The sunroof shade was closed and no glass on the shade because the customer vacuumed off. I did find signs of something hitting the hood and front windshield area and leaving marks. I found the front windshield was cracked and there is a sign of a rock chipping the windshield around the driver wiper area. The customer does drive on a gravel road to their house. There were no signs of the sunroof panel shattering while driving. From the information I gather, it is possible that the glass shattered due to impact, but it is difficult to determine point of impact

❖ **Cause** - The sunroof panel may have been cracked at one point, but with the temperature change being so different in the last couple of weeks may have caused the sunroof to shatter.

❖ **Corrective action** – cleaned up the loose glass and replaced the sunroof panel.

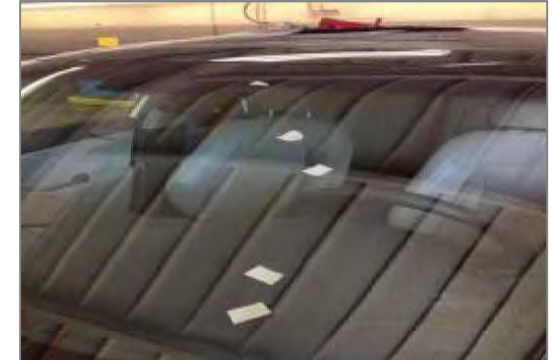
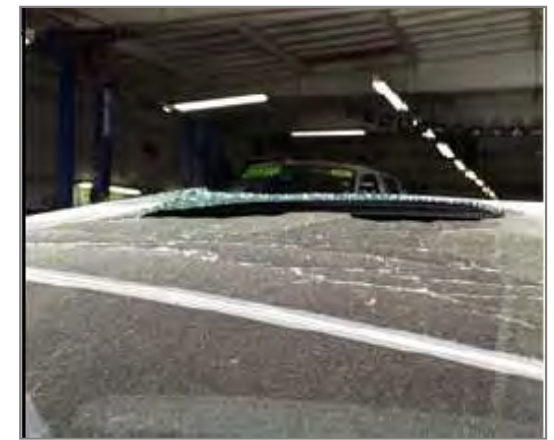
- ❖ Sunroof glass was broken upon inspection

❖ Cause -Unknown

- ❖ **Corrective action** – Panoramic sunroof glass assembly was replaced

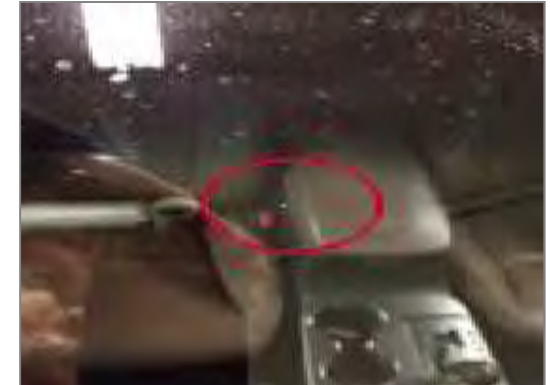
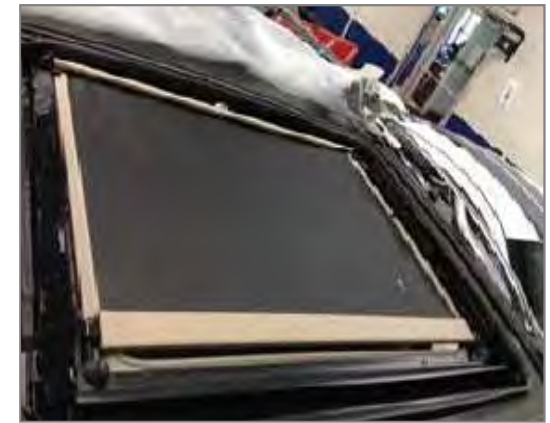
❖ Cause -Unknown

❖ Corrective action – Clean vehicle and replaced movable sunroof glass assembly and sunshade

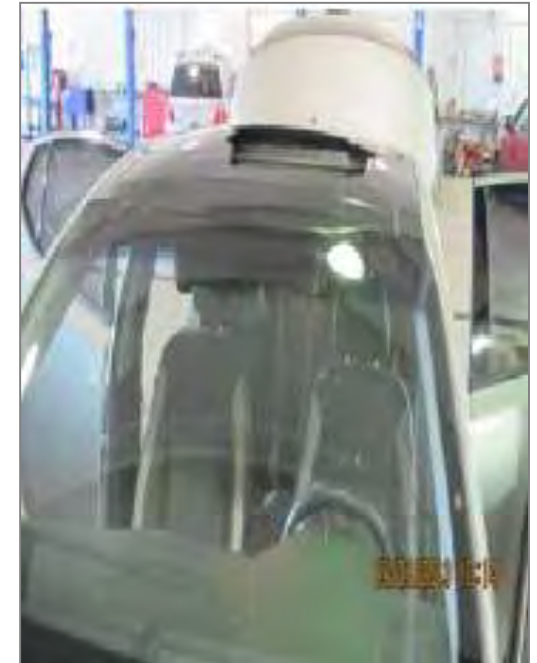
Found that the sunroof had shattered while driving. Found scratches on the trunk lid from glass debris

❖ Corrective action – Replace the sunroof glass

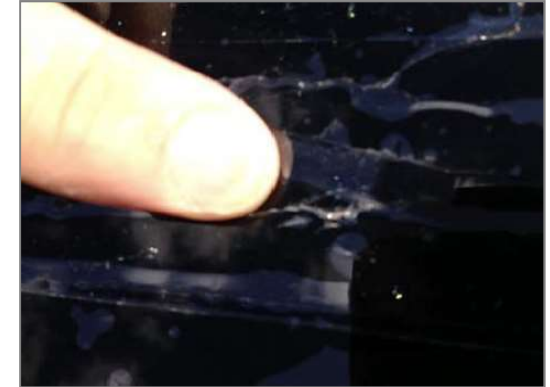
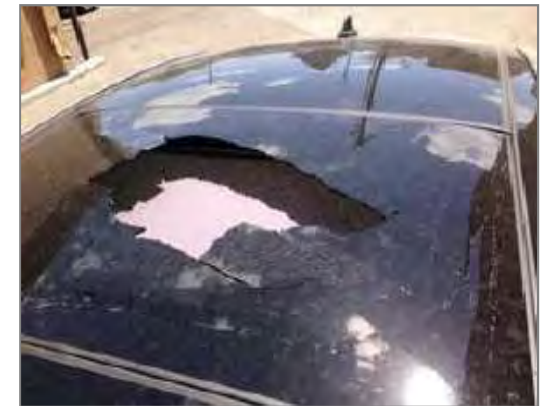
- ❖ VIN = 5XXGR4A64CG^{REDACTED} MILES = 18,507
- ❖ 12MY Optima
- ❖ **Customer complaint**
- ❖ Customer states sunroof glass broke while driving on highway
- ❖ **Actual condition**
- ❖ Vehicle was driven at 10 AM on freeway speed at 70 mph when front panoramic sunroof glass shattered
- ❖ **Investigation Results**
- Multiple small rock impact were identified on front hood and windshield area
- ❖ **Cause** -Unknown
- ❖ **Corrective action** – Panoramic sunroof glass assembly was replaced

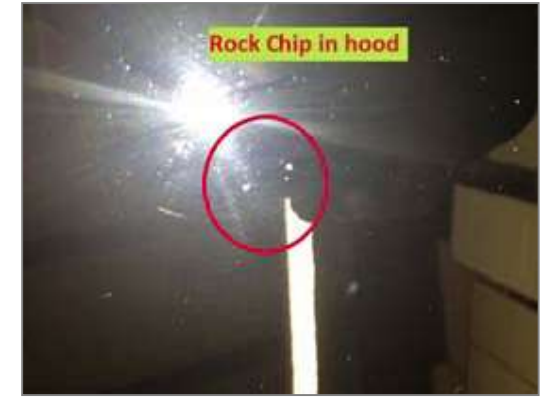
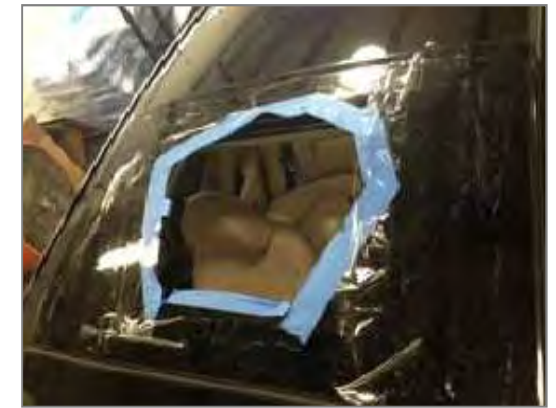
❖ **Cause** - Foreign Object contact glass surface

❖ **Corrective action** – Repair and refinish the rear deck lid surface - replace panoramic sunroof movable glass - clean interior of vehicle. Techline case - T2480594

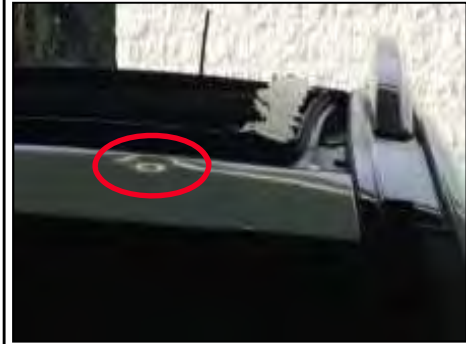
Date	Vehicle Information	Attendees	Summary	Photo	Remark
4	<ul style="list-style-type: none"> • Date: 11/29/12 • Dealer: Temecula, CA (CA269) 	<ul style="list-style-type: none"> • Body : IX- 378717 • Prod. Date : 9/14/12 • Mileage: 1,269 	<ul style="list-style-type: none"> • Pete Ferry (KMA) 	<ul style="list-style-type: none"> • KMA investigated and found large dent on the left side of roof very close to leading edge of glass which they believe to be root cause of glass break • Also found plastic trim piece in front edge of roof opening has signs of impact and discoloration due to bending as well as a small tear.

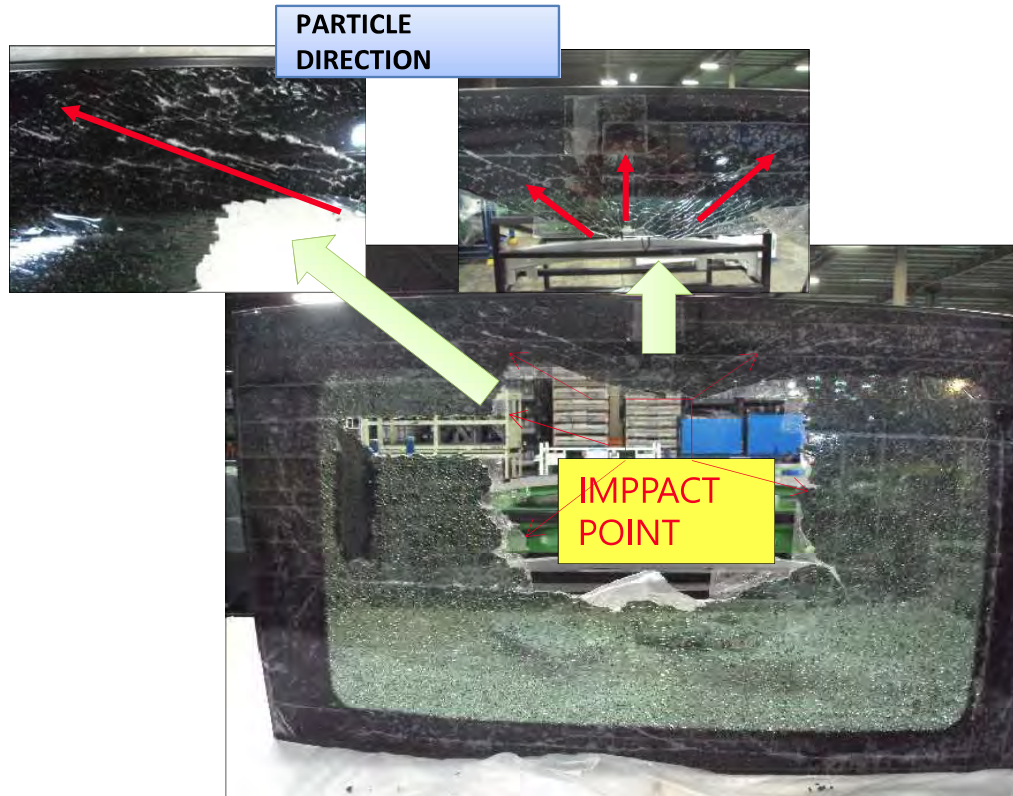
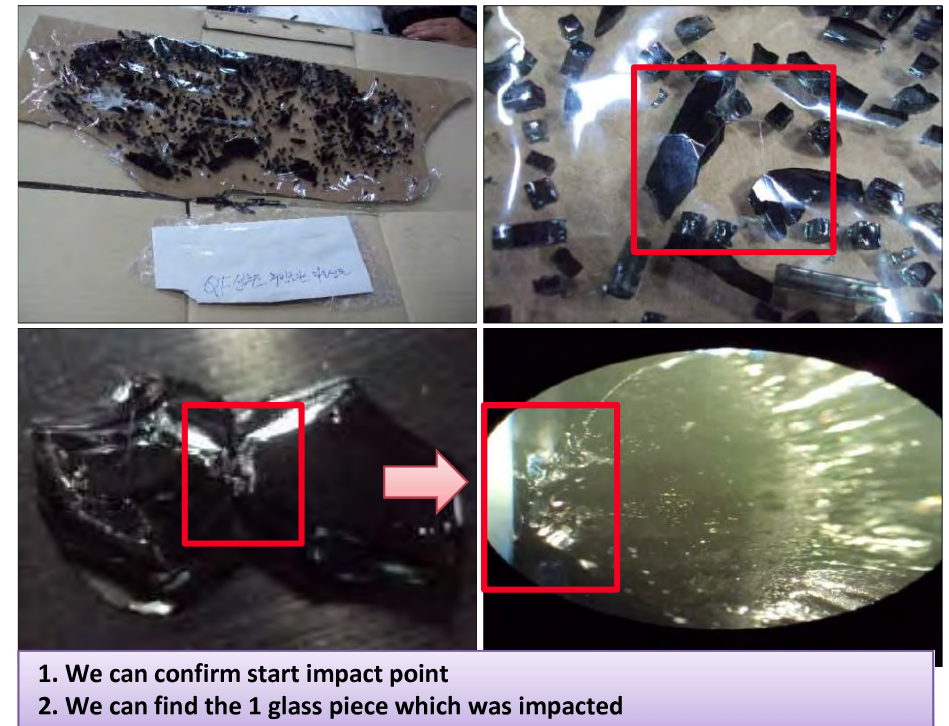
■ QF SUNROOF SMALL PIECES REPORT

- OCCURANCE COUNTRY: NORTH AMERICA
MODEL : QF(TF) Front
CRASH POSITION: FRT CENTER AREA

※ RESULTS OF INVESTIGATION: SMALL PIECES GLASS WAS OCCURRED DUE TO OUTER IMPACT.

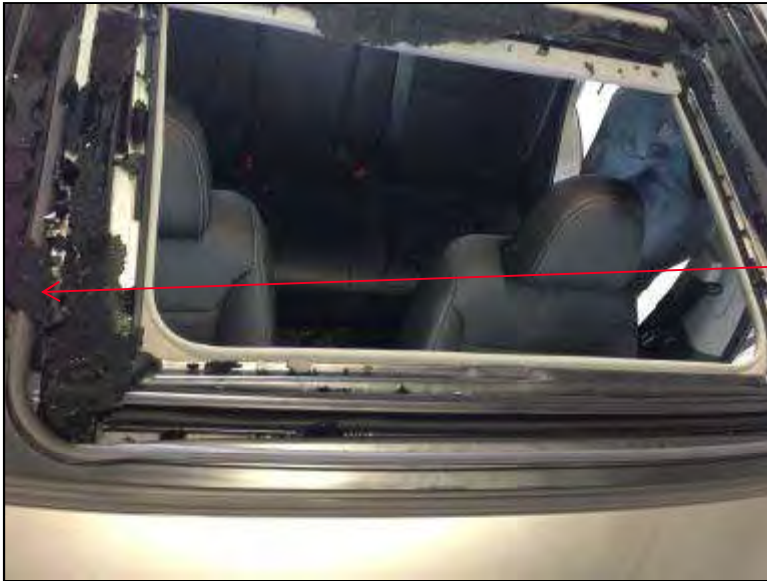
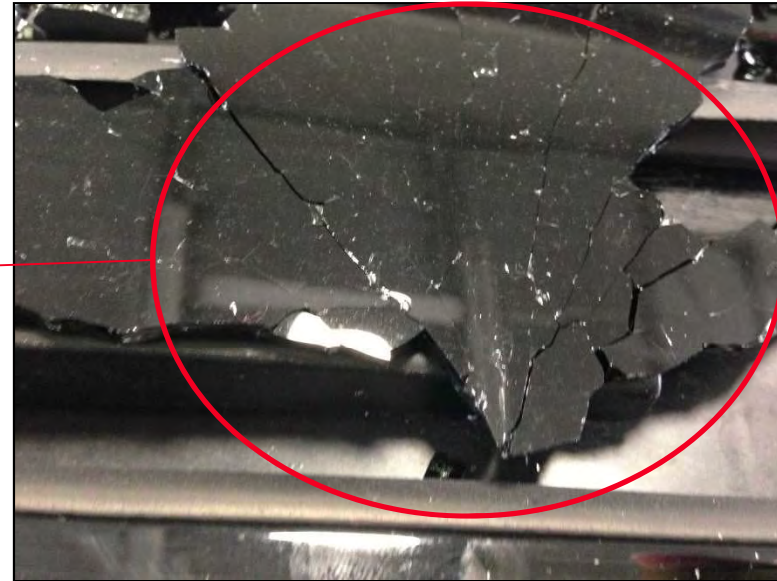
- After glass analysis by Guardian, damage to glass appears to have started on right side of the glass. No other areas on the glass still present on the vehicle showed a web-like break pattern as found on the right side. This web-like break pattern indicates where the crack began due to some sort of external impact to the glass.
- No foreign debris found within the sunroof track or vehicle.

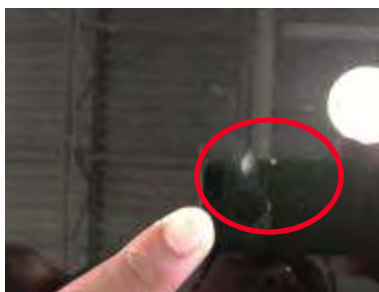
Witness Markings on Rear Glass Panel

Some scratches were noticed on the rear glass. There are two potential causes:

These scratches could occur if something was indeed mounted to the roof and the glass was damaged during that process or (2) it could have been damaged by glass fragments from the front glass panel after it fractured on the highway.

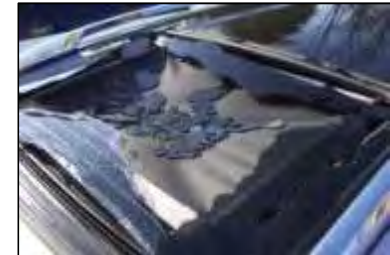
- During evaluation there was some damage to the roof at the rear sunroof panel.
- After initial analysis of glass fragments, tempering of glass appears to be within specification.

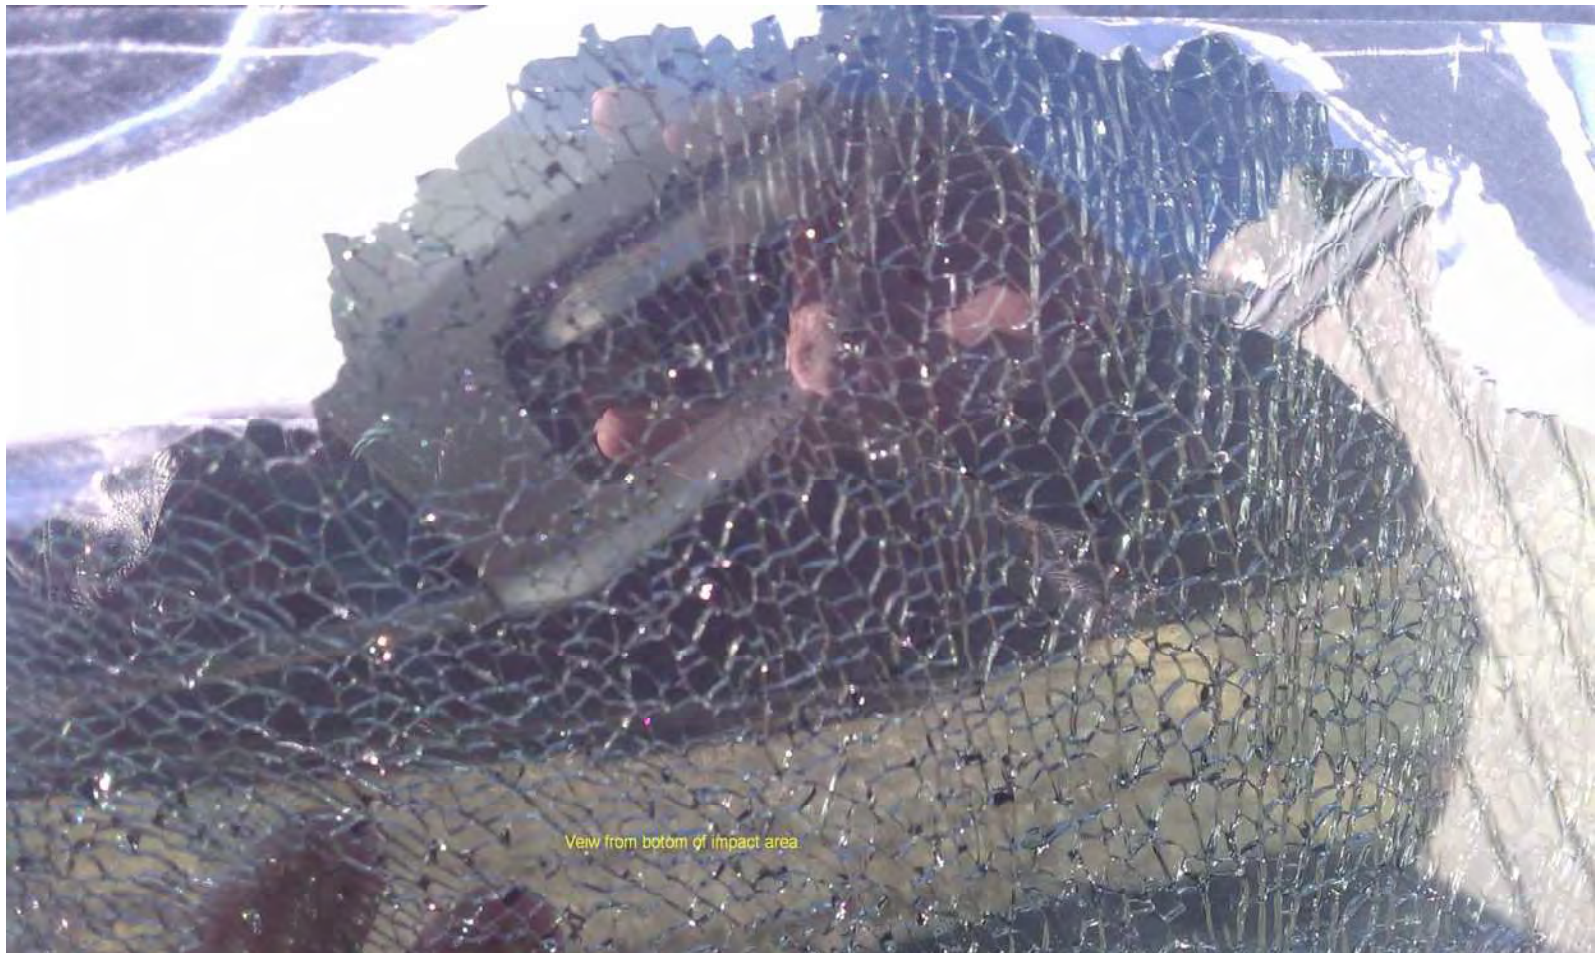
Impact Area (close up from the bottom)

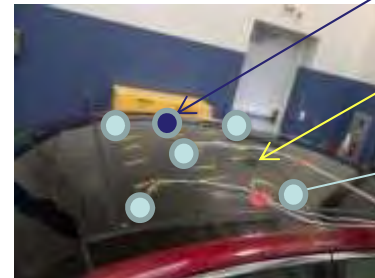
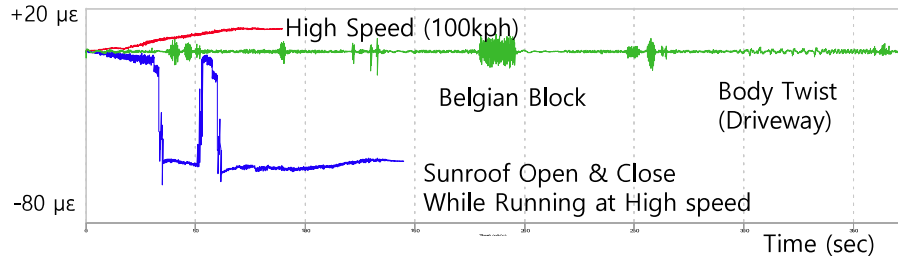
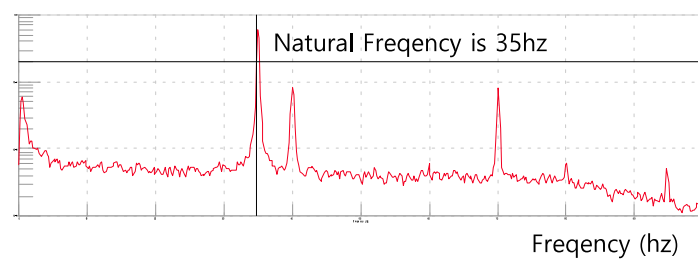
Purpose	To reproduce of QF/XM sunroof glass shattering issue.
Background	Customer / Field complaints of Panorama Sunroof Glass Shatter - Currently 9 Reported Incidents to NHTSA QF : 1 Case, XM : 8 Cases
Details	<p>1. Strain gages were placed at 5 points of QF sunroof(4 corners, center). 2. Several conditions were tested:</p> <ul style="list-style-type: none"> a) Aero Dynamic (high speed) / Random Road Input b) Body Twist c) Loud Audio (sound pressure) d) Door & Roof Operation. <p>(1) Front corner shows highest strain (not center) (2) Most severe event is 'Open & Close sun roof while running high speed', but not a high level (below 0.5kgf/mm², 70microstrain)</p> <div style="display: flex; align-items: center;">

</div> <p>2. Durability test of 2,000mile was finished and no sign of crack on both QF & XM. With artificial [X] scratch at center of roof, vehicles completed 2,000 miles of testing with no cracking. * Test conditions</p> <ul style="list-style-type: none"> a) Car Wash after soaking (hot/cold). b) Oval driving 5 Lap with different windows opening/closing for pressurization, door slams. c) Durability loop events
